Report of Inspection Results of the First Dry Storage Cask at Fukushima Daiichi Nuclear Power Station

March 27, 2013

Tokyo Electric Power Company

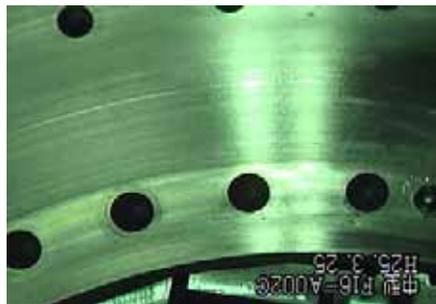
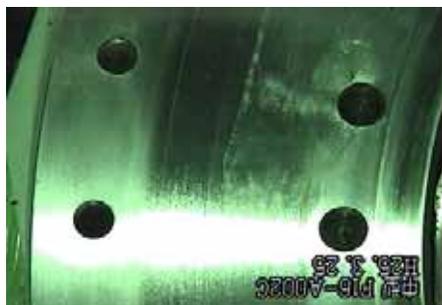
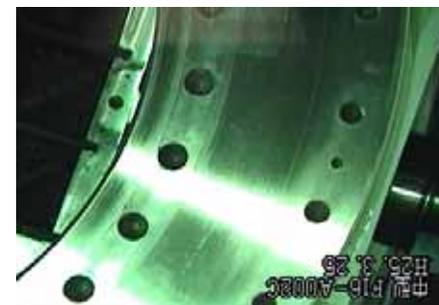
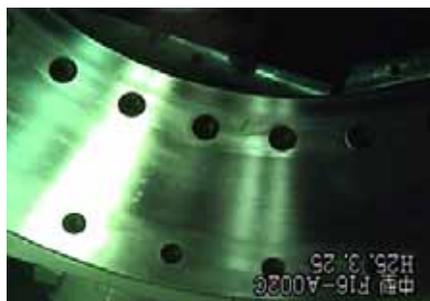
External Appearance of Cask Flange Surface

-It was confirmed that there were no abnormalities such as flaws, cracks, etc.

Observation of the flange surface of the dry storage cask

It was confirmed that there were no abnormalities such as flaws, cracks, etc.

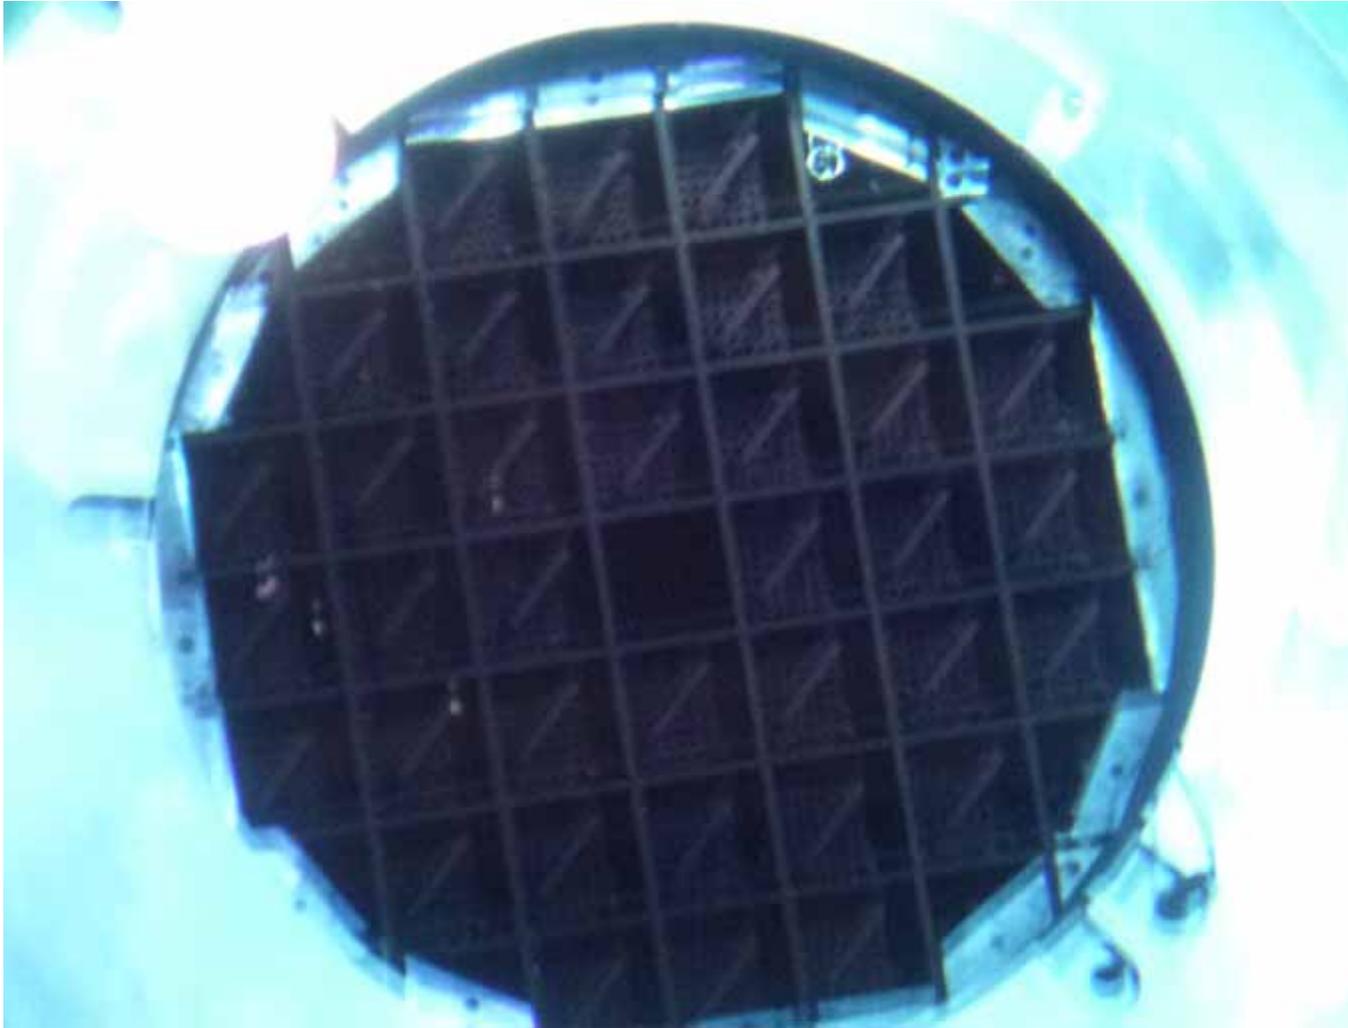
Result of External Appearance Observation of Basket

It was confirmed that there were no abnormalities such as deformation, damage, etc.

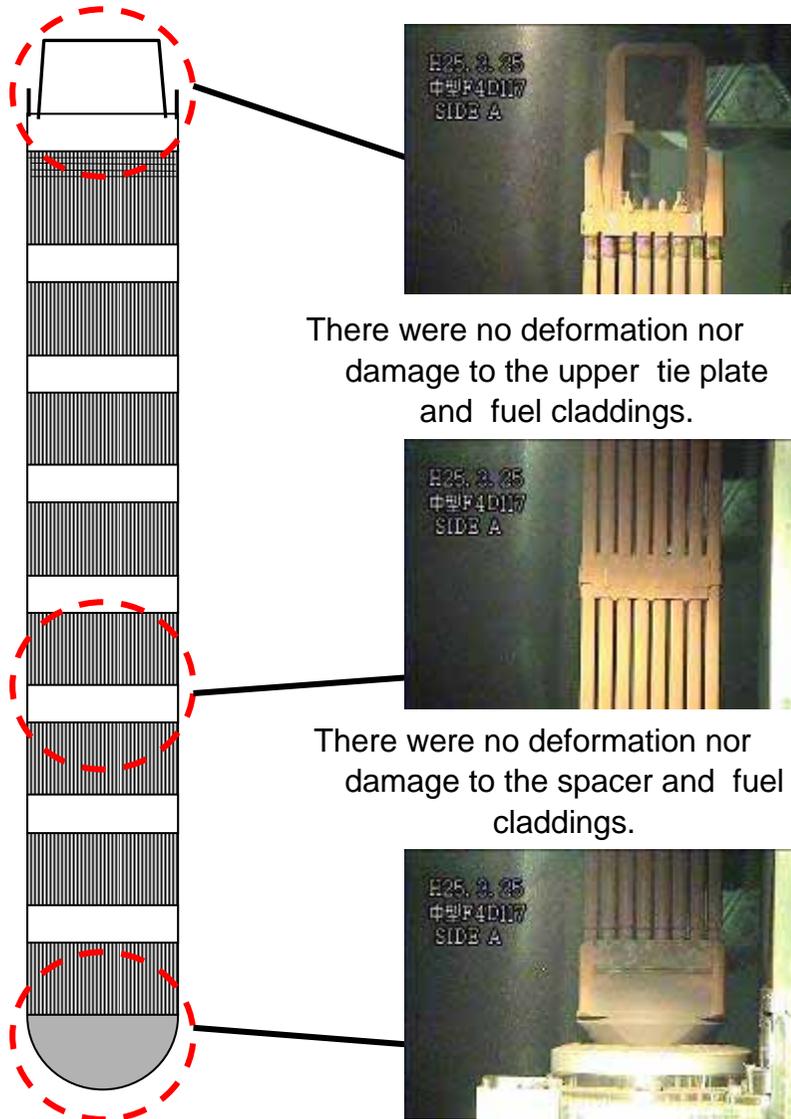
Result of External Appearance Observation of Fuel Assemblies

There were no deformation nor damage to the upper tie plate and fuel claddings.

There were no deformation nor damage to the spacer and fuel claddings.

There were no deformation nor damage to the lower tie plate and fuel claddings.

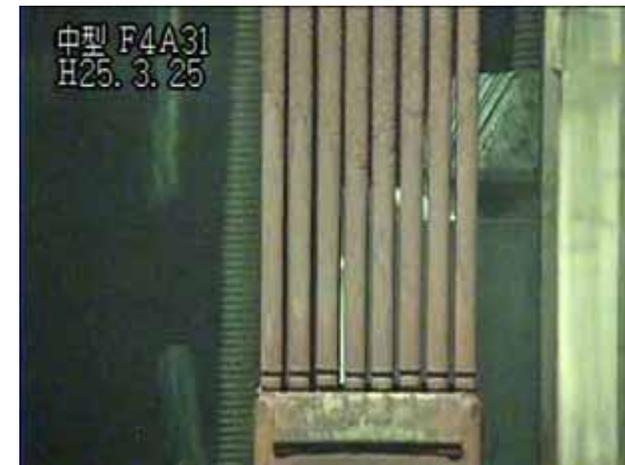
Examples of Inspection Results

It was confirmed that there were no abnormalities such as deformation, damage, etc. in the three spent fuel assemblies.

It was observed that there was crud flaking from the surface of one of the three claddings, which does not affect the fuel integrity.
