Report of Inspection Results of the First Dry Storage Cask at Fukushima Daiichi Nuclear Power Station

March 27, 2013

Tokyo Electric Power Company

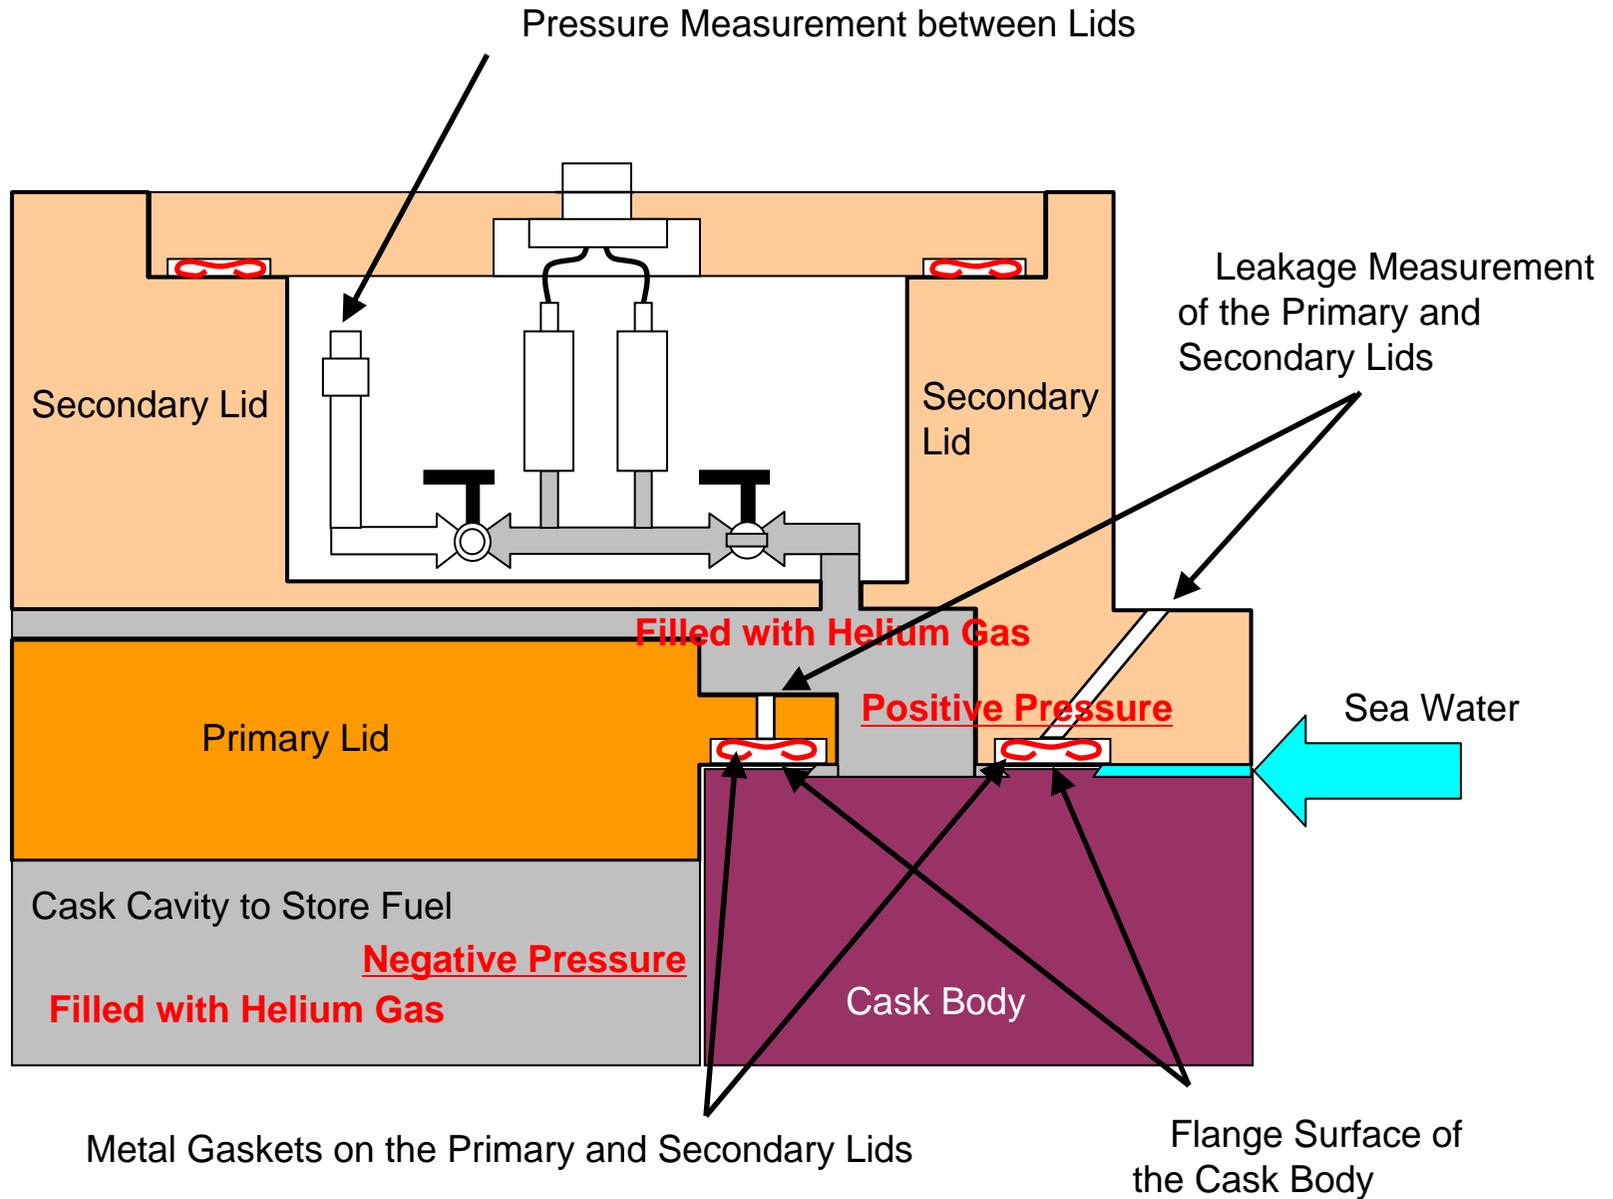
Cross Section of the Lid Structure of the Dry Storage Cask

4 . External Appearance of the Metal Gaskets for the Primary and Secondary Lids.

-It was confirmed that there were no abnormalities such as flaws, cracks, etc.
on the primary gasket.

-It was confirmed that the metal gasket for the secondary lid was corroded at the outer circumference by the sea water intrusion, but that there was no penetration and the cask cavity was separated from the external environment.

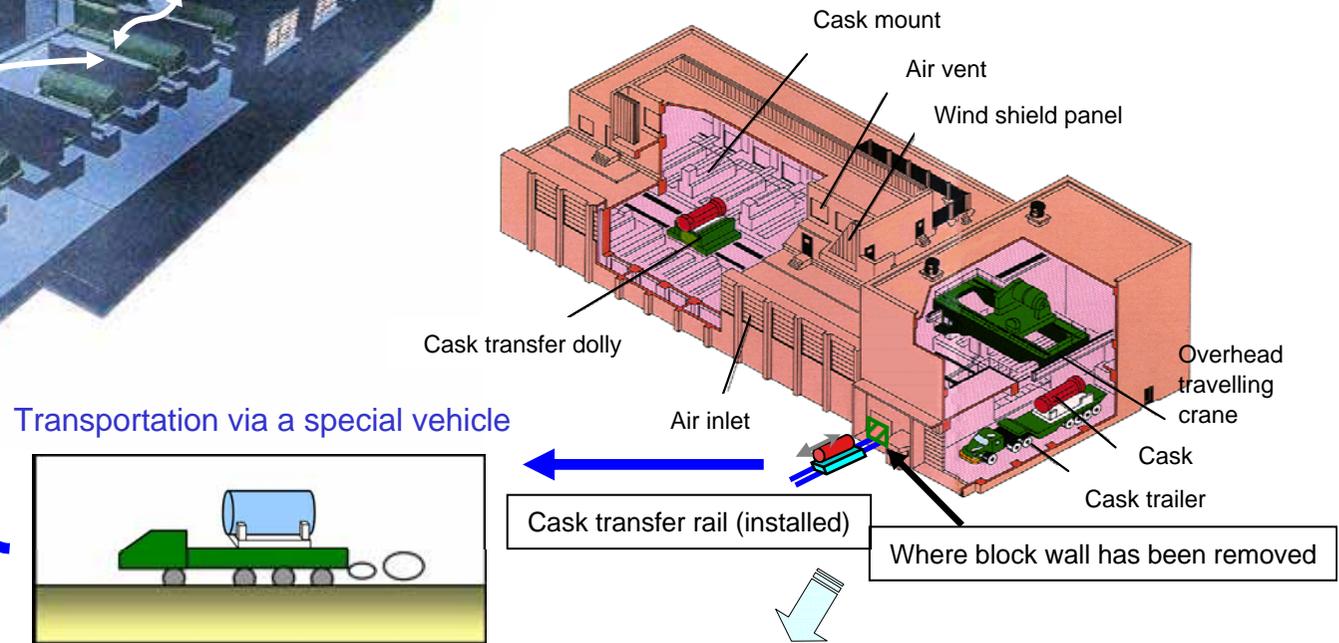
New exit and cask transfer rail were installed, because the overhead crane for the dry storage casks can not be used due to the disaster.
